BUILDING SCIENCE SERIES 40

Engineering Aspects of the 1971 San Fernando Earthquake

This report presents the observations of the NBS on-site inspection team (most photographs in this report were taken by the team). The material presented herein is intended to serve as (1) a documentation of damage resulting from the earthquake and (2) as a source document for further studies, research, and recommendations. This is particularly important as necessary remedial work and restoration have resulted in the removal of evidence that is essential for studies and evaluations.

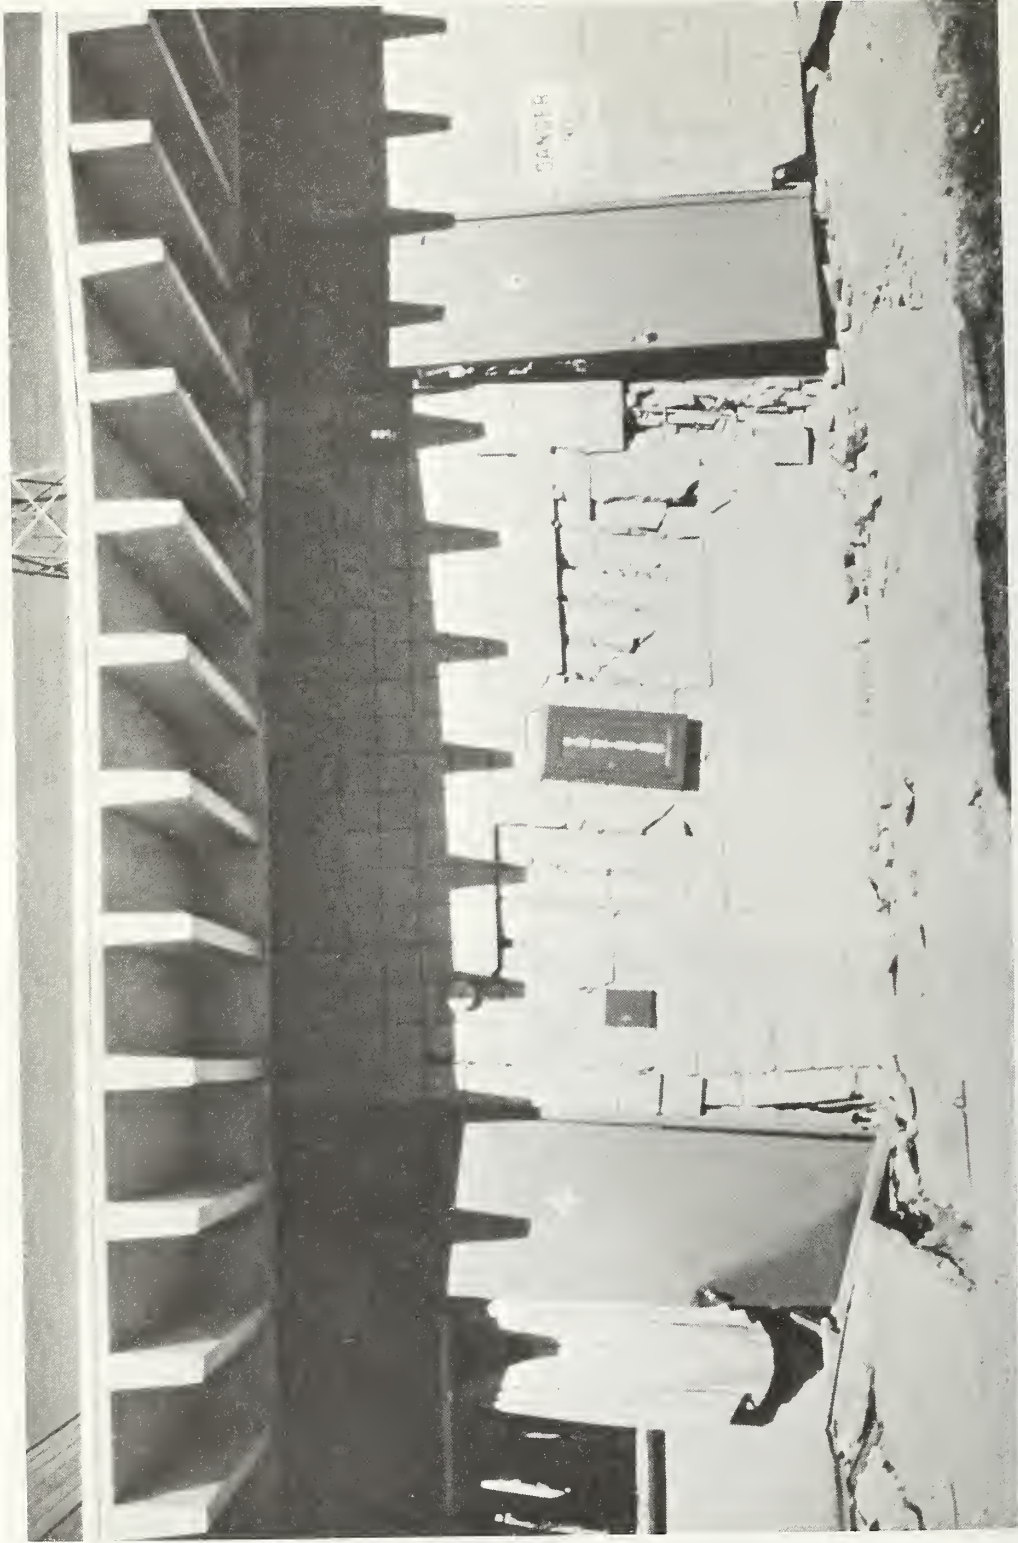
Figure 6.48 Damage to girls' school adjacent to cafeteria, Los Angeles County Juvenile Facility. The solidly grouted concrete block wall resisted the distortion.

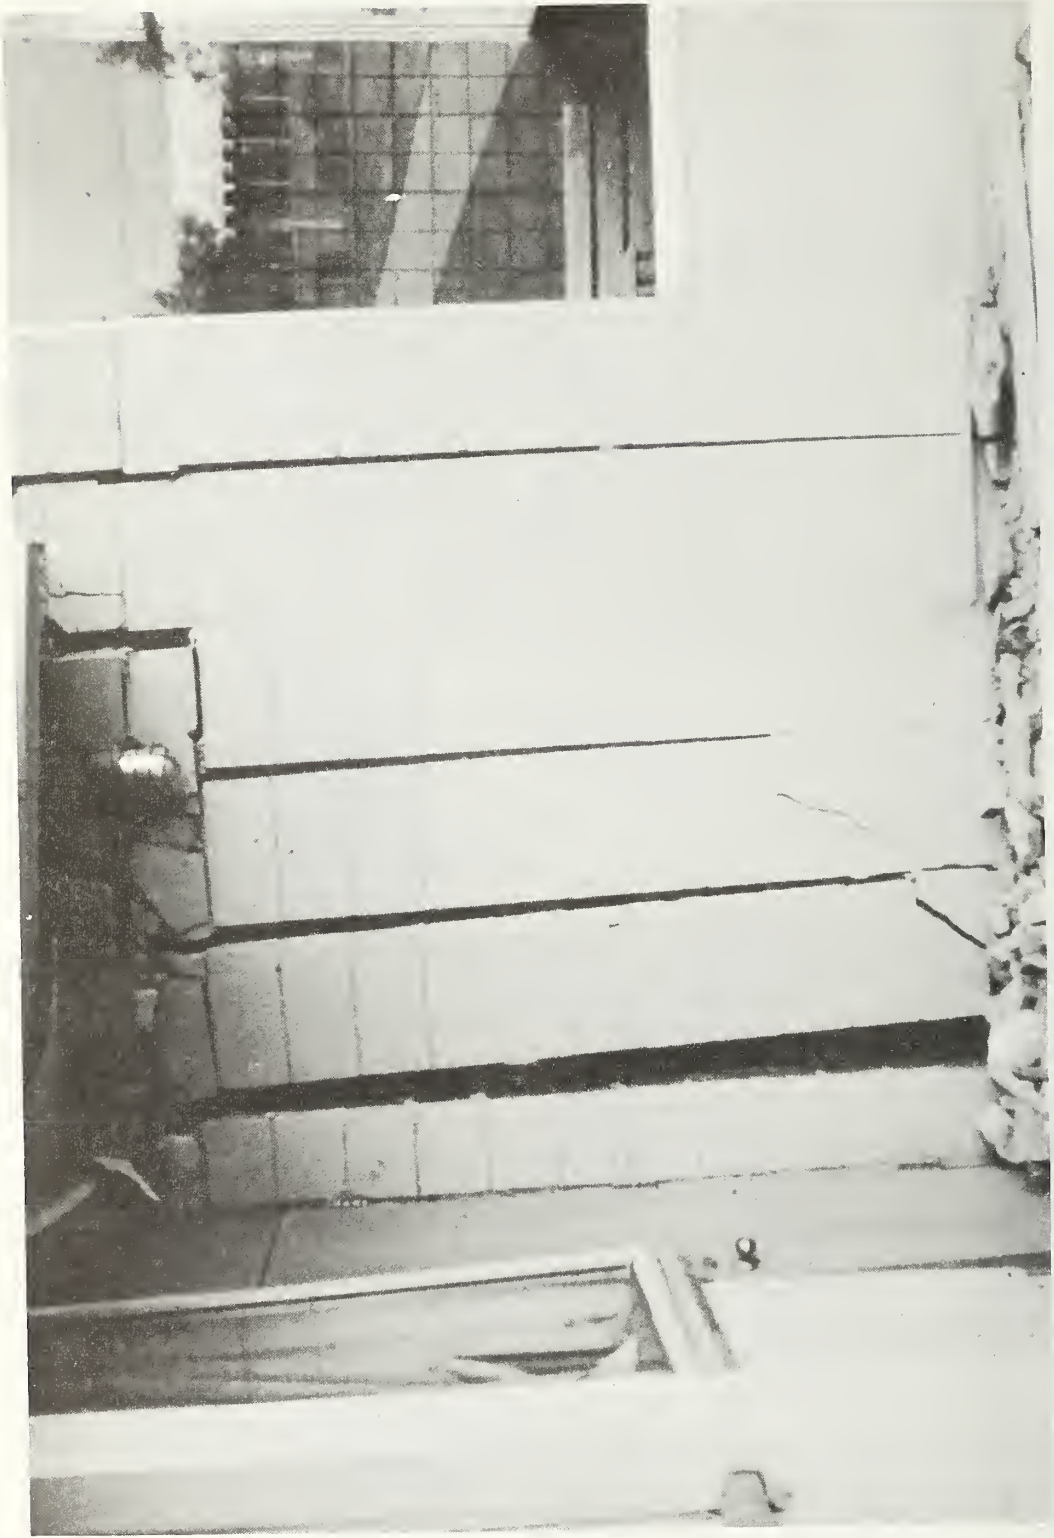
Figure 6.51 Damage to concrete block wall, Los Angeles County Juvenile Facility. Note absence of horizontal reinforcement. Only reinforced vertical cells are filled with grout.

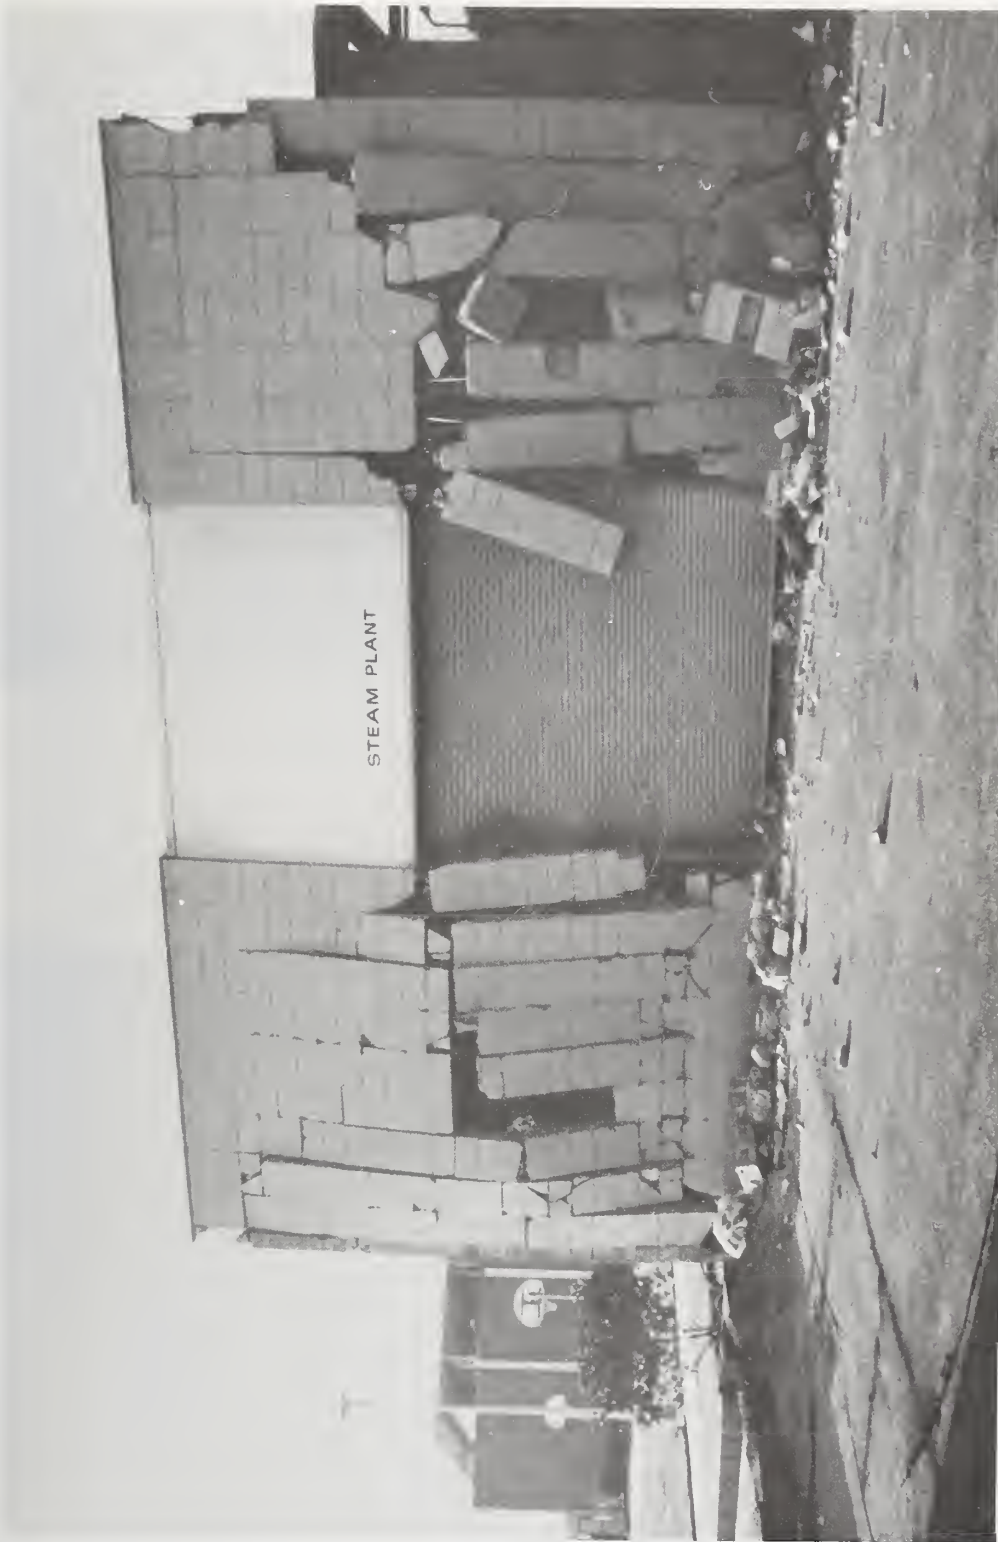
Figure 6.52 Damage to concrete block wall, Los Angeles County Juvenile Facility. Note absence of horizontal reinforcement. Only reinforced vertical cells are filled with grout.

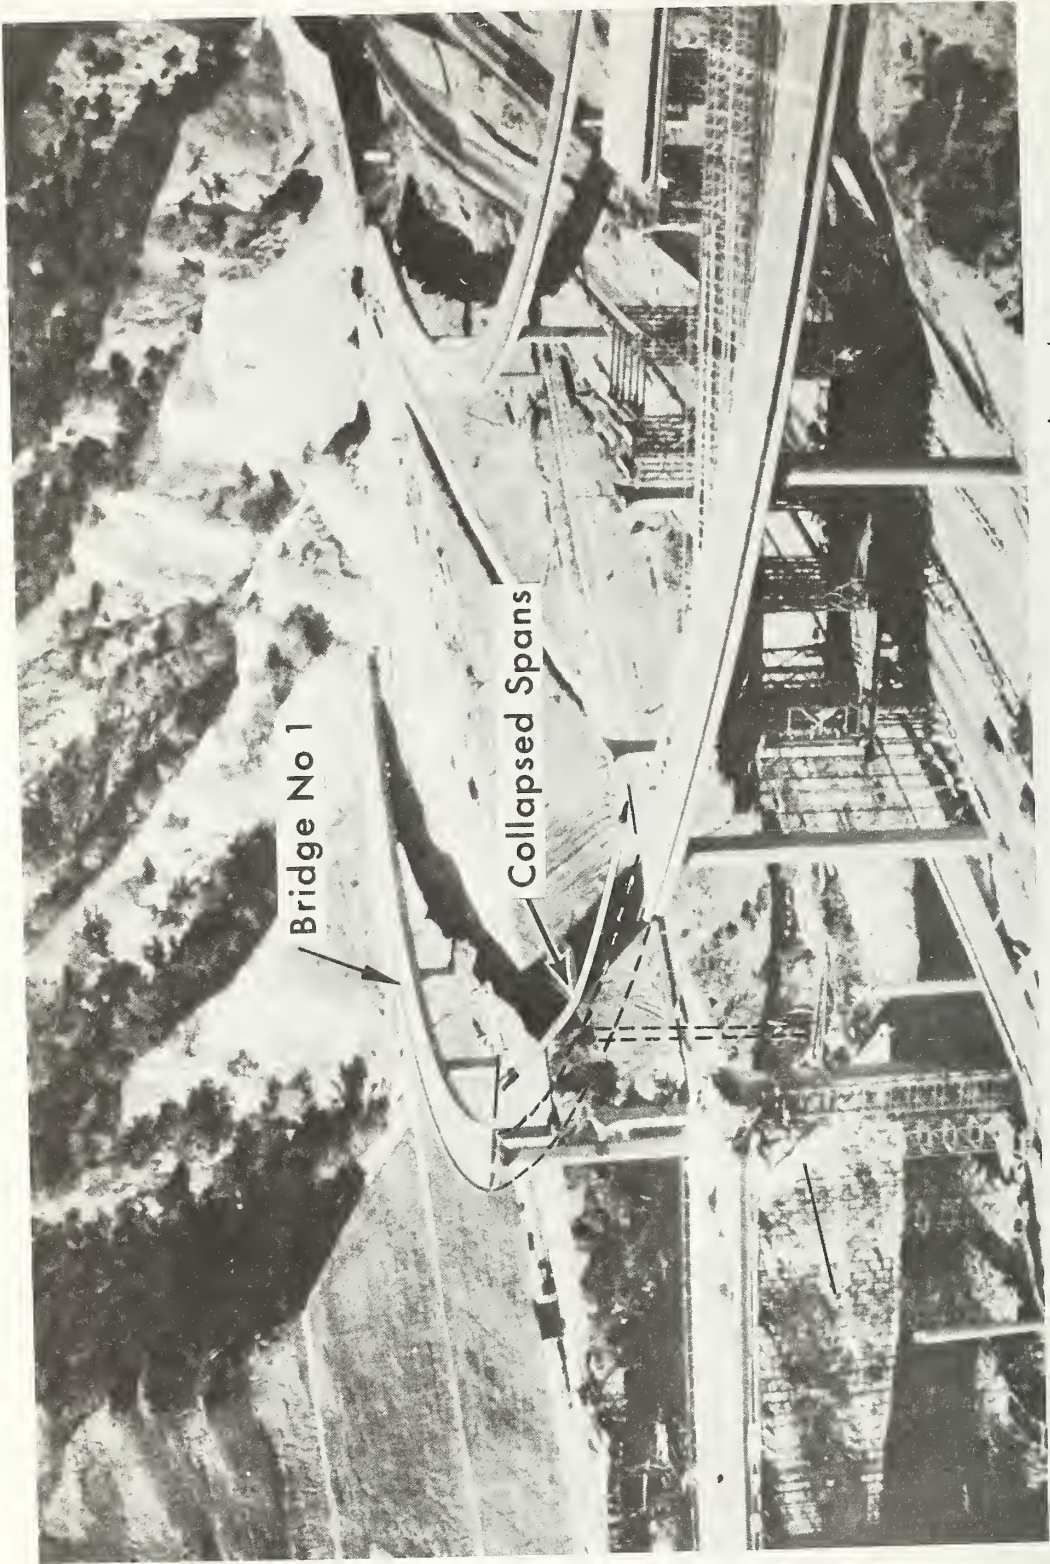
Figure 7.2 Collapse of the South Connector Overcrossing at Palmdale interchange.

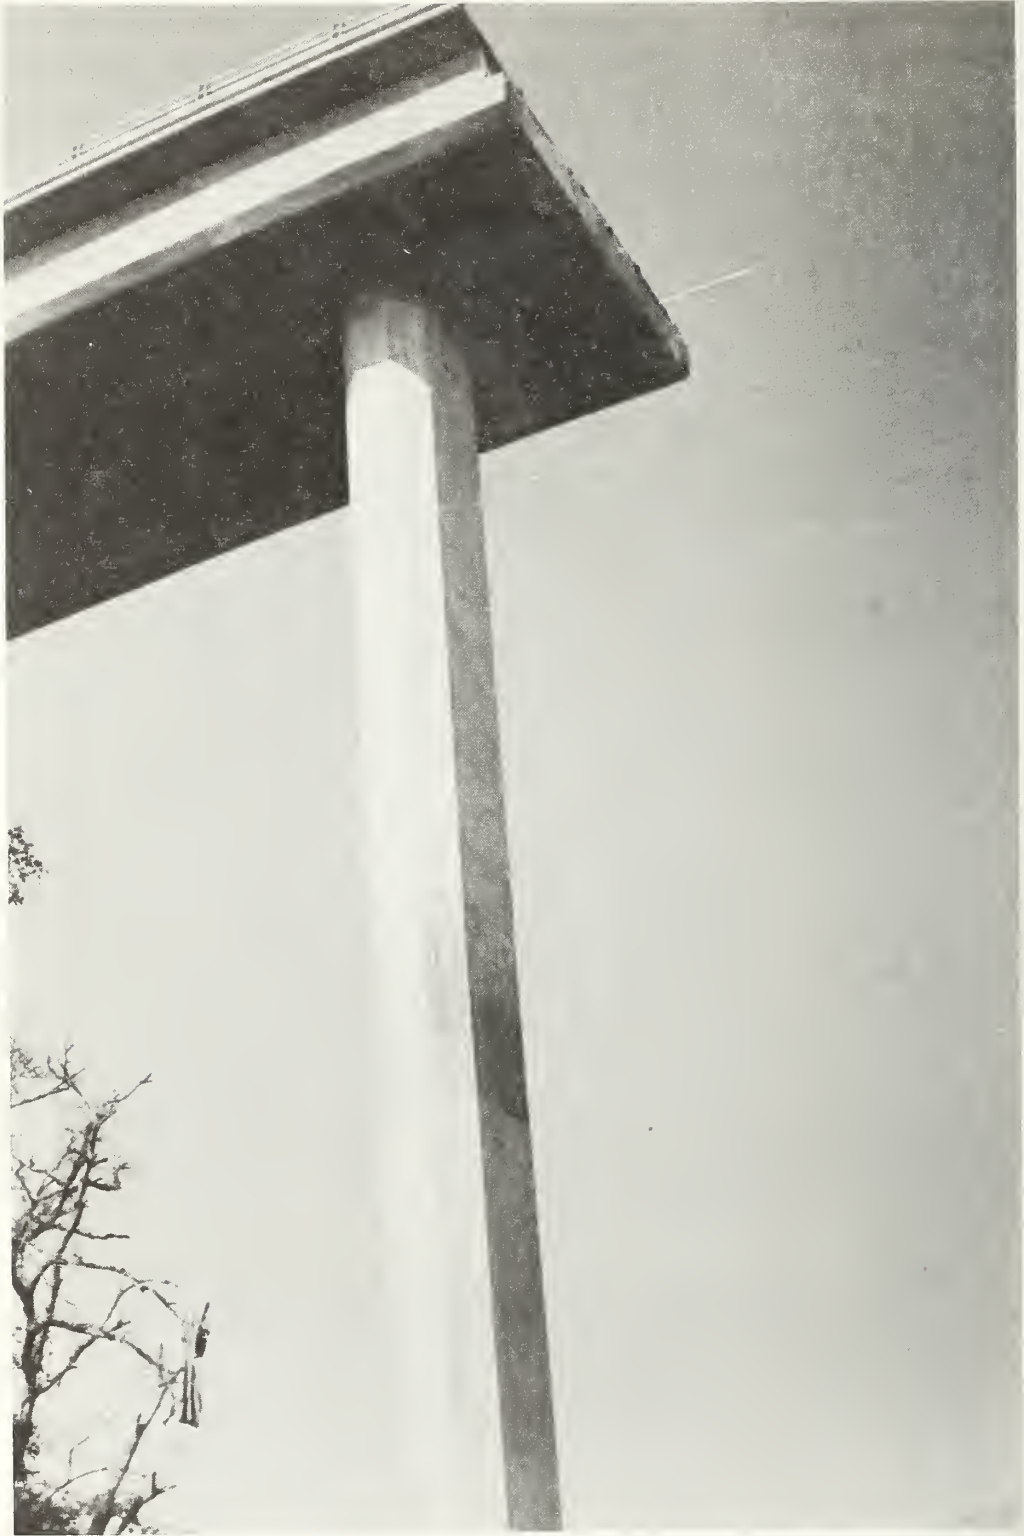
Figure 7.5 Post-failure view of Pier 5 and hinge seat.

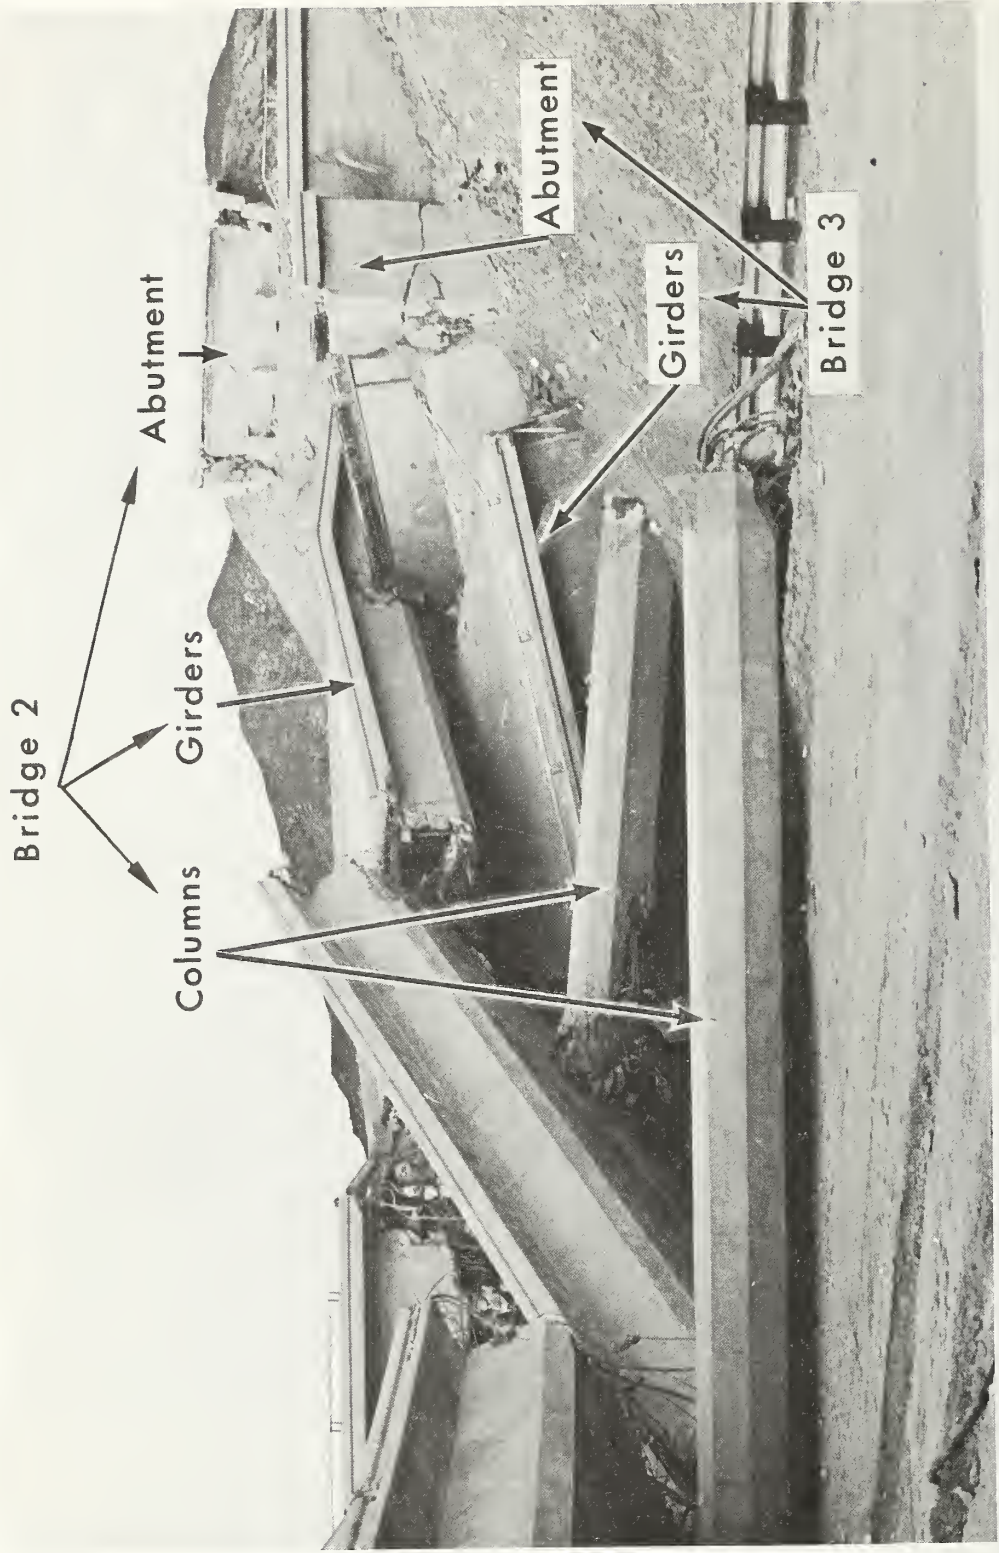
Figure 7.18 Collapsed girders and columns of the IS 210/5 Separation and Overhead structure (Bridge 2) on top of the collapsed Northwest Connector Overcrossing bridge (Bridge 3).

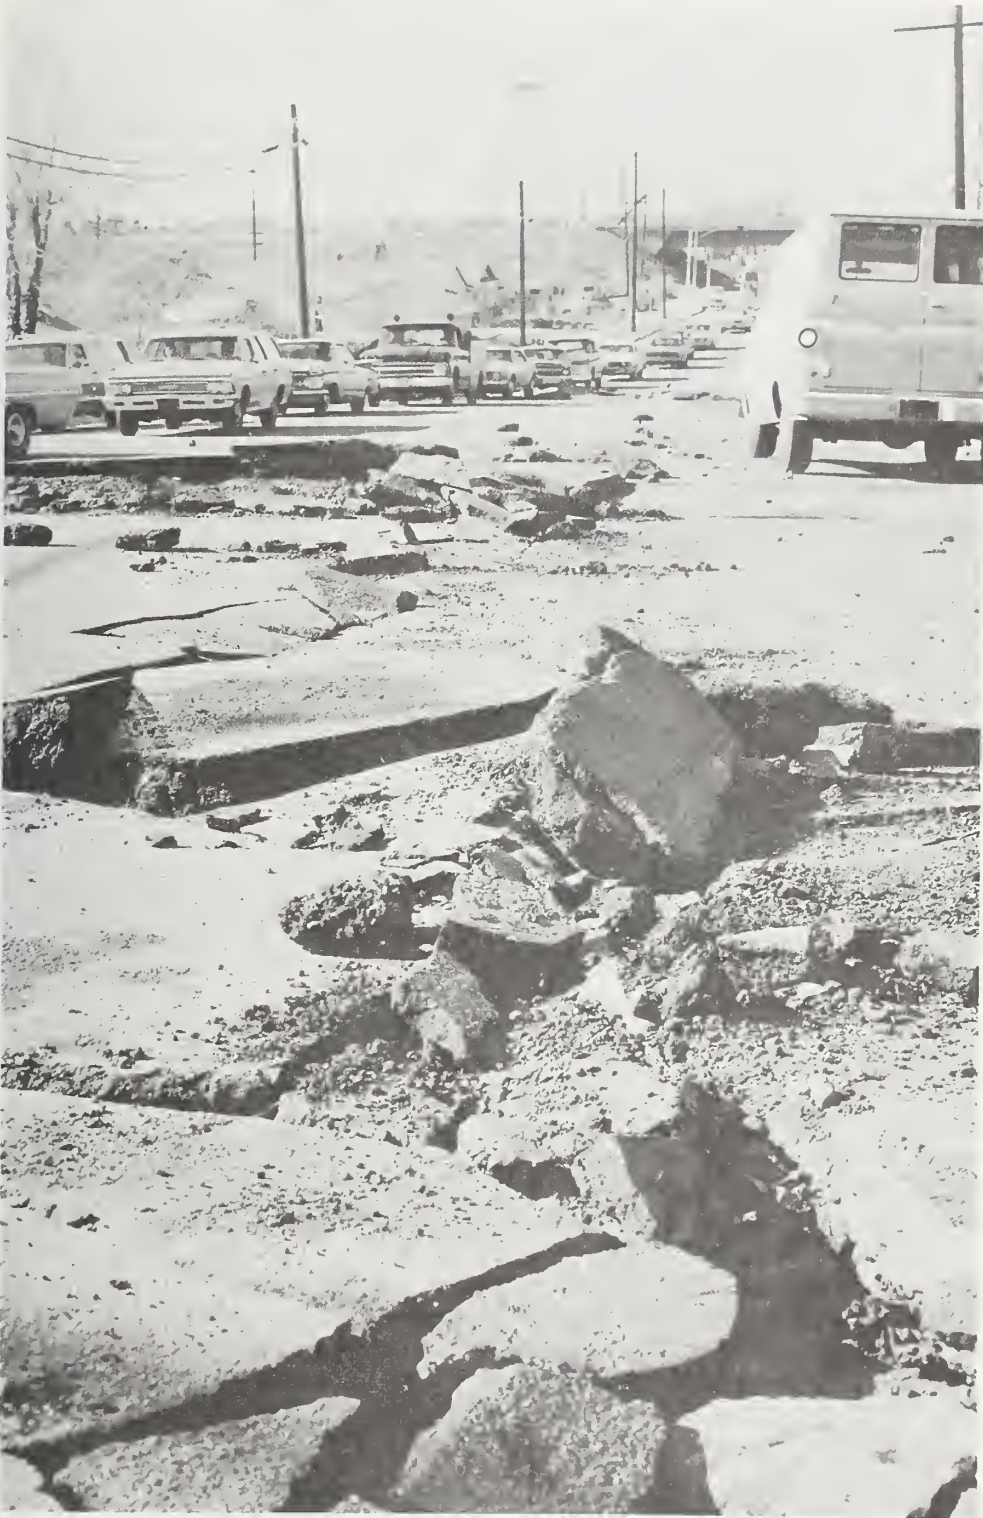
Figure 7.43 Buckled street in Sylmar near Harding Elementary School. (Los Angeles Times Photo.)

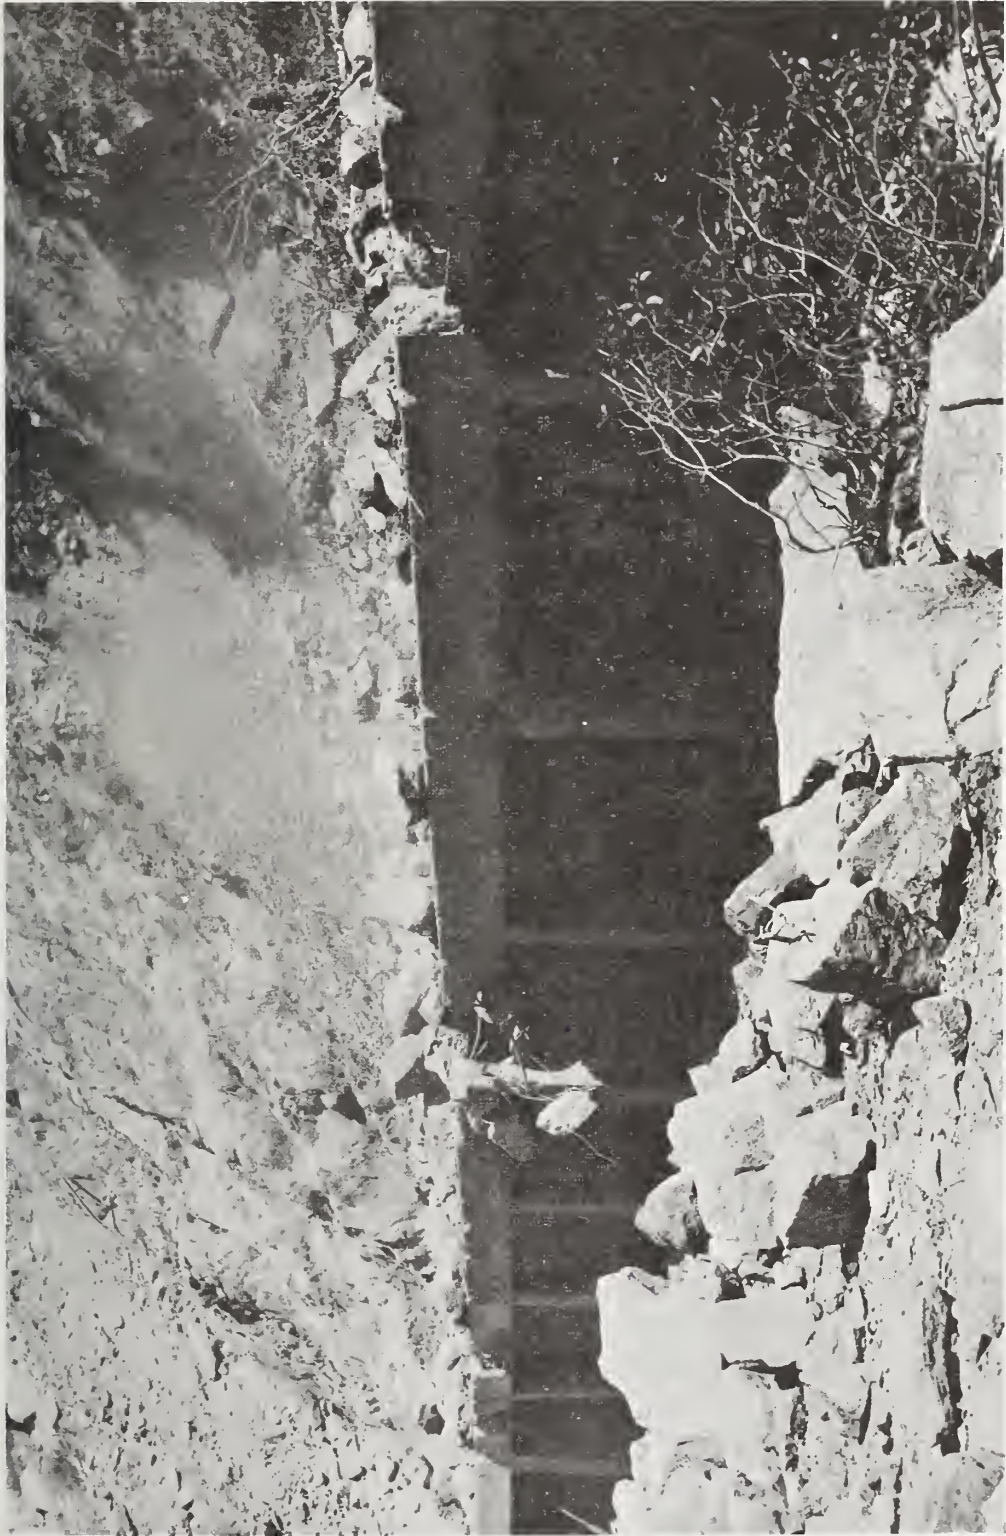
Figure 8.29 Slides on access road along covered walkway, Pacoima Dam.
